Nevins Log House

F-6-84 Nevins Log House Thurmont, Maryland Frederick County

Survey No. F-6-84

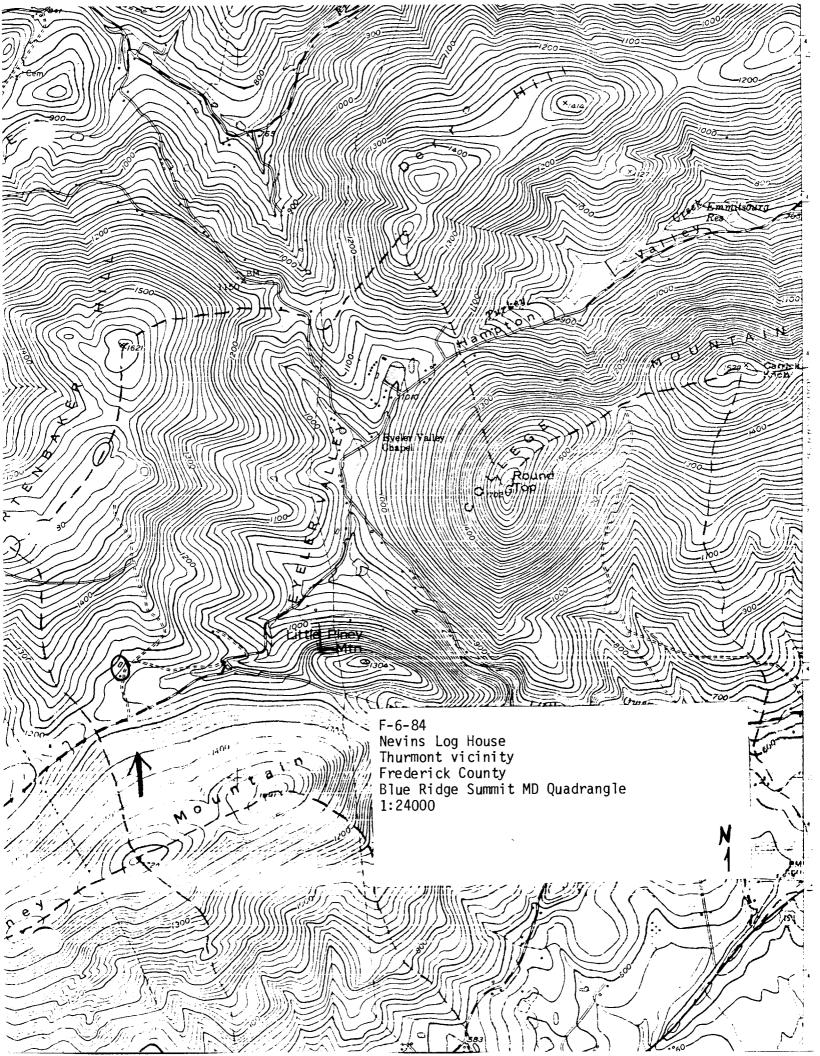
F-6-84 NEWINS LOS HOUSE 6994 Eylers Valley Flint Road Thurment claimity frederick County
Photo: MARY K SHIDE JUNE 1991 NEC, LOC: MHT North devation + springhouse

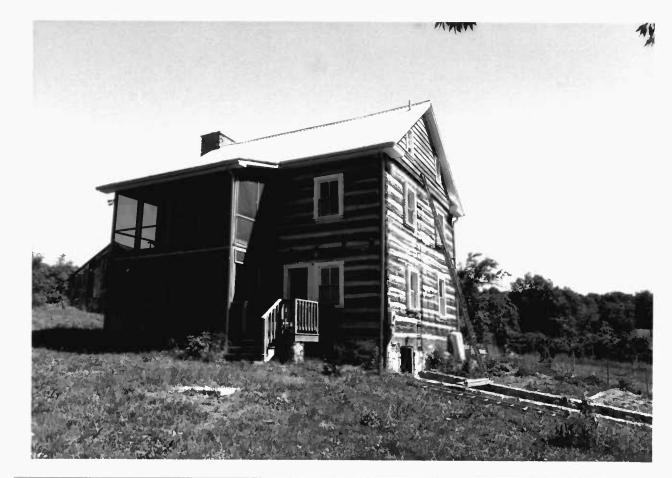
F-6-84 NEWINS LOC HOWE 16994 Eylers Valley Flint Road Frederick County Prote: MARY K SHIPE Tue 1991 NER. CC: MHT Sorth Elevation

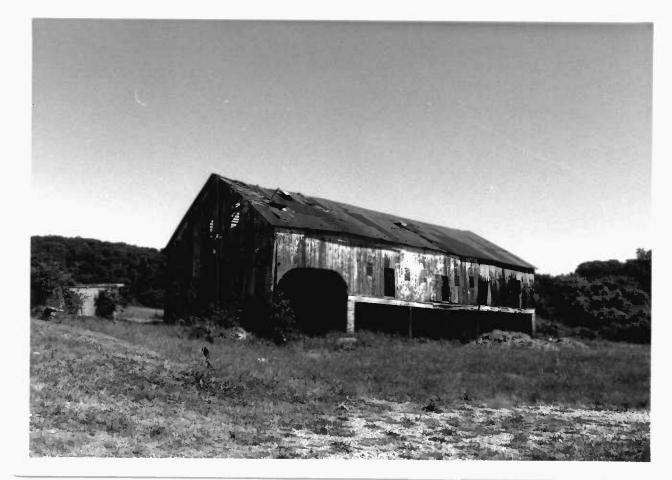
F-6-84 Nams les Hass 6994 Eylers Valley Flint Road Frederick Country Proto: MARY K SHIPE JNE 1991 NEG LOC: MHT

BARN-looking west
